Manhole Inspection Summary

Manhole # S11QQ1006MH

Insp Date: **4/27/07 11:05 AM**

Location Address: **5000 PIMLICO ROAD**

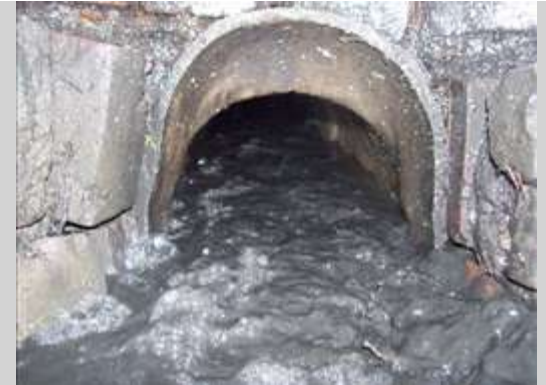
12 O'Clock Outflow

8 in. Circular Gravity Sewer
Pipe Out @ 12 O'Clock

Pipe Height: (in.) Direct
Pipe Material: **PVC** ☐ Pipe Lined
Invert Depth: **6.15** (ft.) Flow Characteristics: **Slow**
Deposits: ☒ None ☐ Mud ☐ Sludge ☐ Debris ☐ Grease
Silt Depth: (in.) Deposits Extent:
Infiltration: **None** Pipe Seal Cond: **Sound**
